Expert Review of Design Documentation for Projects in the Chernihiv Region

New Construction of a Civil Protection Shelter – a Dual-Purpose Facility with Protective Properties of a Radiation Shelter for the Needs of Oleshnianskyi Lyceum named after S. F. Rusova of the Dobrianka Settlement Council, located at 4-A Shkilna Street, Oleshnia Village, Chernihiv District, Chernihiv Region

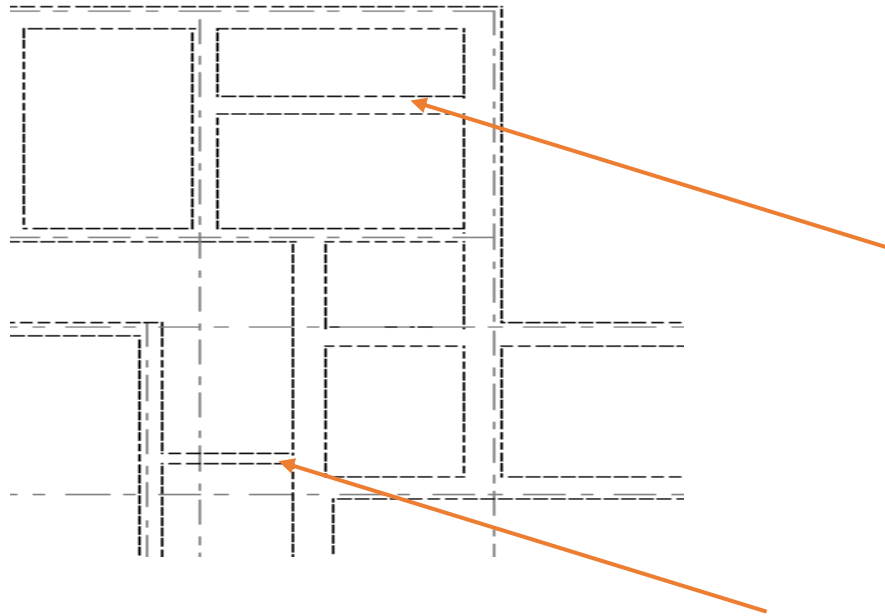
5. The axis setting-out plan (AR 03) does not comply with the requirements of DSTU 9243.4:2023 “System of Design Documentation for Construction.” In particular, some structural elements do not have designated axes, which must be defined using numerical or alphanumeric indices with decimal notation (for example, 1.2 or A.1).
