Expert Review of Project Documentation for Projects in Chernihiv Region

“New Construction of a Civil Protection Facility (Radiation Shelter) at the address: Chernihiv Region, Chernihiv District, city of Oster, B. Khmelnytskoho Street, 76-A”

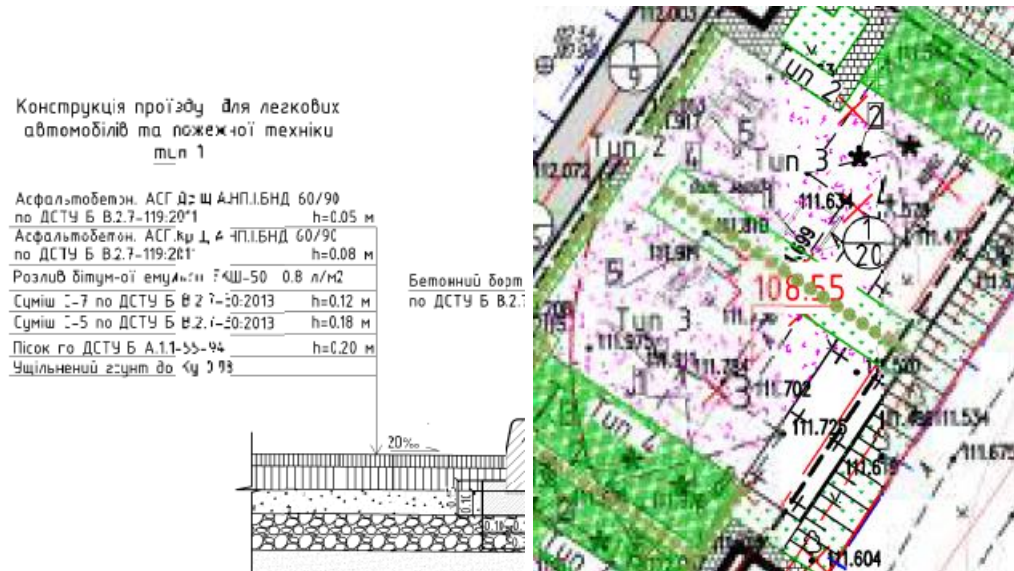
6. Very low quality of drawings in the electronic version of the sets of working documentation (GP albums).
